# WAUSHARA COUNTY MASTER PLAN

March 16, 2021

## INTRODUCTION

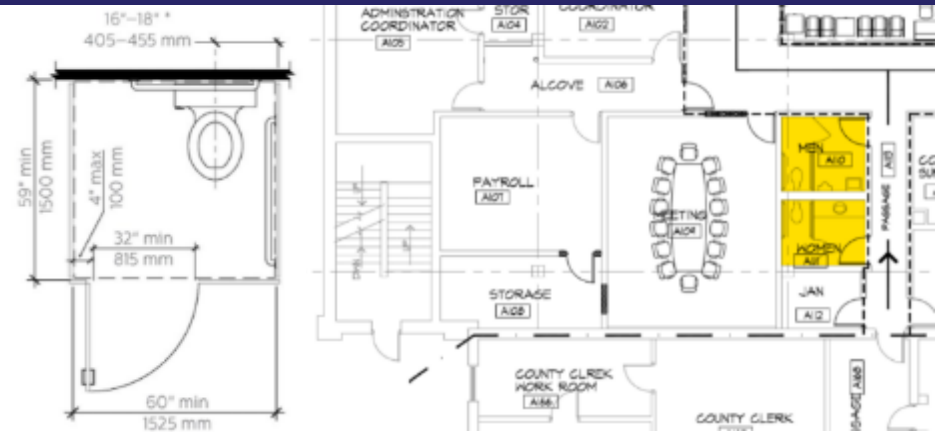
The first-floor restrooms toilet stalls shown to the right in the 1977 building do not meet the required ADA floor space clearances. The recommended solution for these restrooms would be to remove the partitions and convert the rooms into ADA compliant single user restrooms.

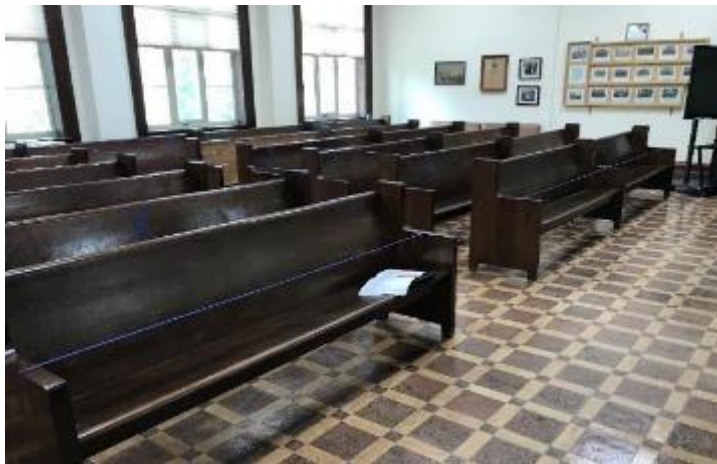
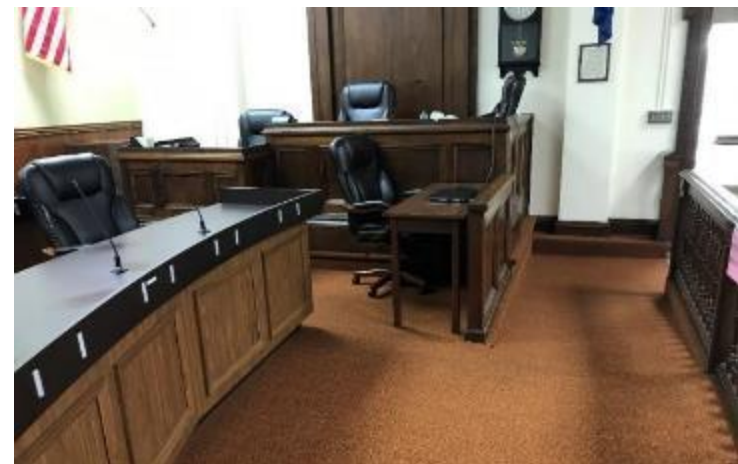
The current County Board room is a space that should be thought through regarding its accessible accommodations. The public seating area currently consists of fixed benches rather than loose chairs. Fixed benches are better from a security standpoint, but do not easily accommodate individuals who use wheelchairs. The other space which should be redesigned is the elevated seating area that the County Board works from. There is a ramp that gets you to the elevated platform, but the fixed furnishings prevent someone in a wheelchair access to the board seats beyond that. Additional accommodations are recommended.

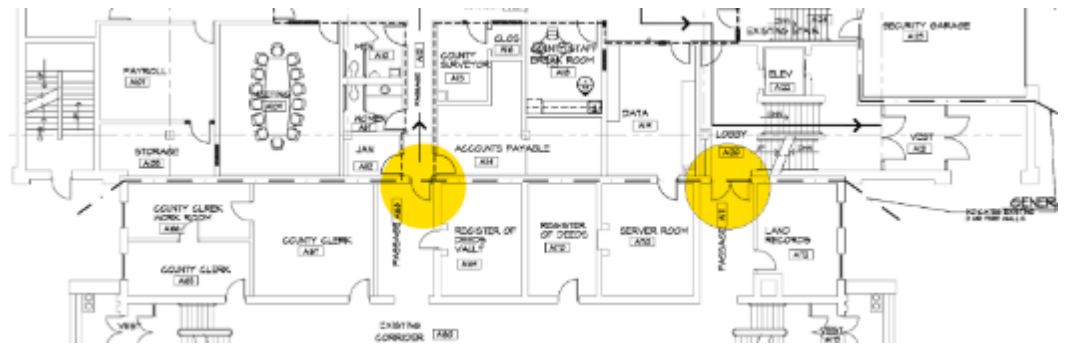
The fire doors that separate the 1929 building from the 1977 addition had wood wedges holding the doors open during the walkthrough, which is a violation of the Life Safety Code, section 19.3.6.3.10. If there was a major fire and the doors were stuck open, the fire could more easily spread from one building to another which will not only cause greater damage, but potential result in occupant injury or death. While having these doors held open is more convenient for occupants, it needs to be corrected for occupant safety. Possible solutions include changing the doors to have magnetic hold open devices or install fire shutters which would allow free open access side to side, while offering an automatic protection in the event of a fire.

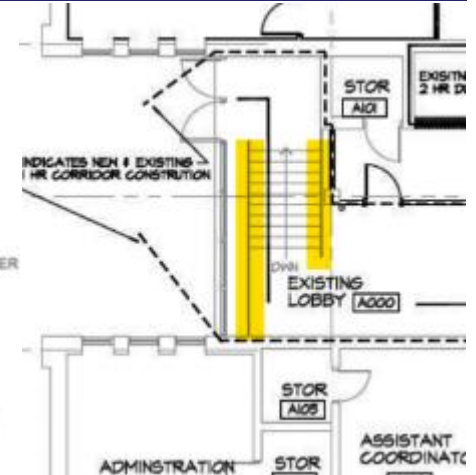
Between the Administrators office and Human Services, the existing lobby stairs currently has a guardrail that does not meet the code requirements. The code requires that a 4" sphere cannot pass through between either the members of the guardrail. This guardrail however is spaced at 11" apart. One possible solution is to modify the existing guardrail by adding intermediate members to reduce the opening size. Another possible solution is to replace the guardrail with a code compliant design.

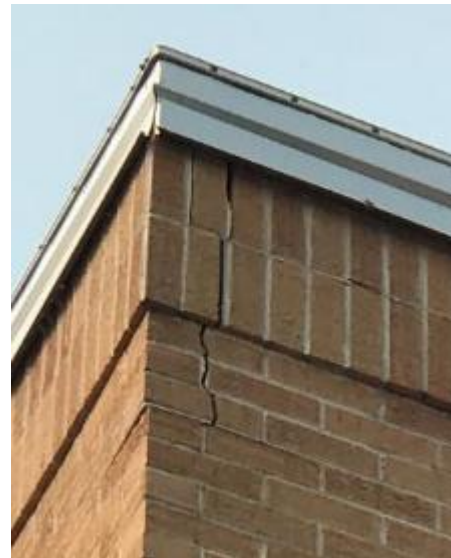
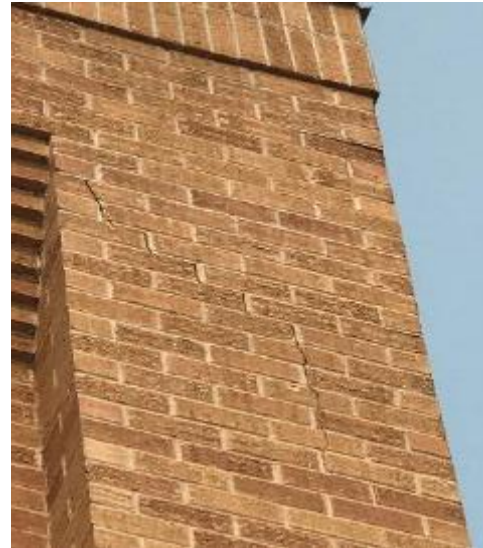
The 1929 building and 1977 building have different but compatible structural systems and are typical for courthouse and government administrative buildings from the times they were built. The elements are described on page 8. No major obvious structural issues were found during the casual observation walk throughs. There were a few minor cracks in the 1977 buildings masonry veneer that are likely the result of minor differential movement over time which could be addressed by tuck pointing and replacement of damaged bricks.

Brick and mortar cracks in veneer likely caused by slight differential movement over time on 1977 building.

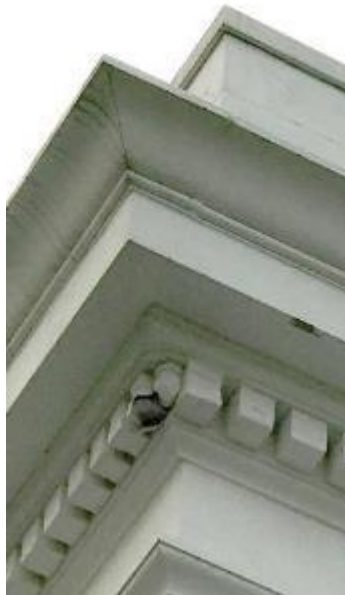
Dentil / paint damage.

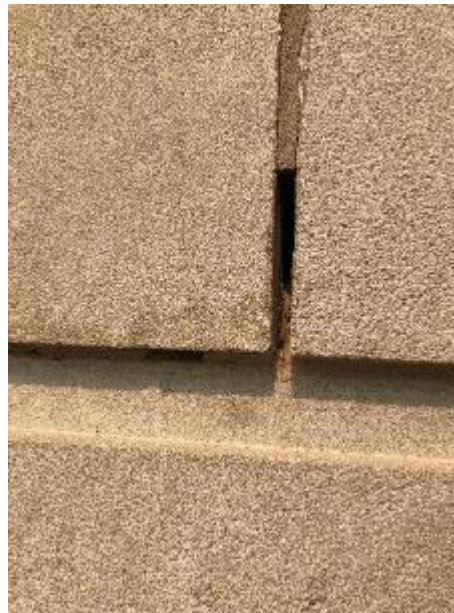
Tuck pointing needed.

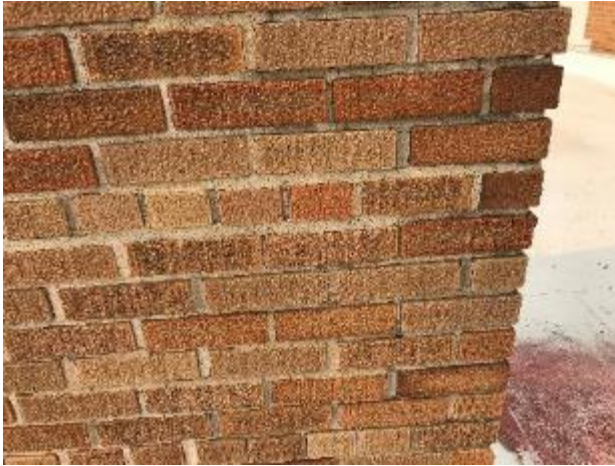
Tuck pointing, cracks and some brick repair needed at chimney.

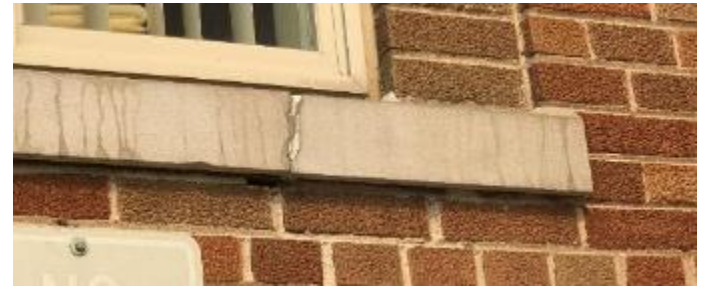
Tuck pointing, brick, decorative stone and paint repair needed.

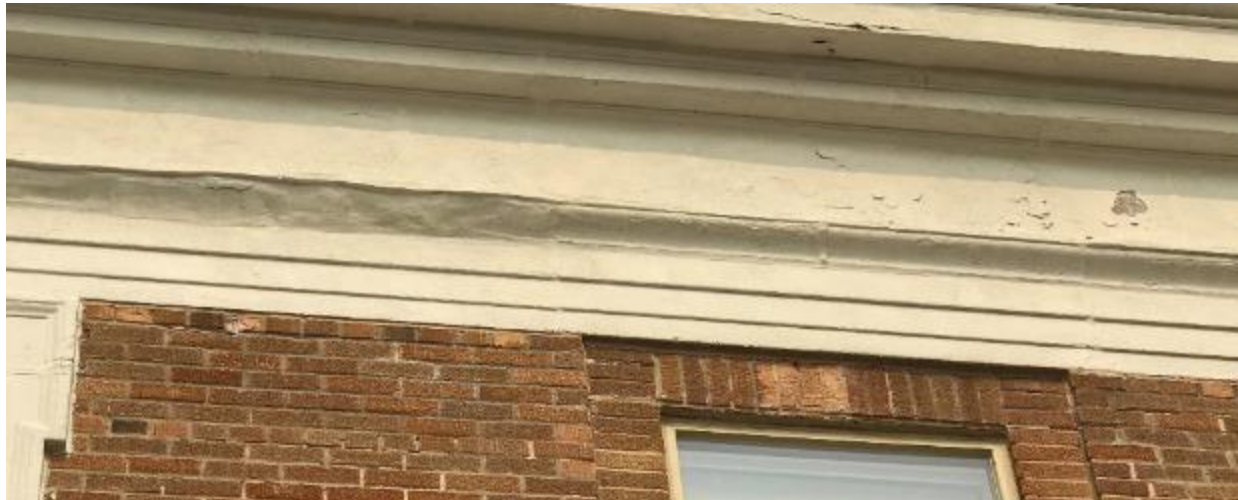
Tuck pointing, brick and paint repair needed.

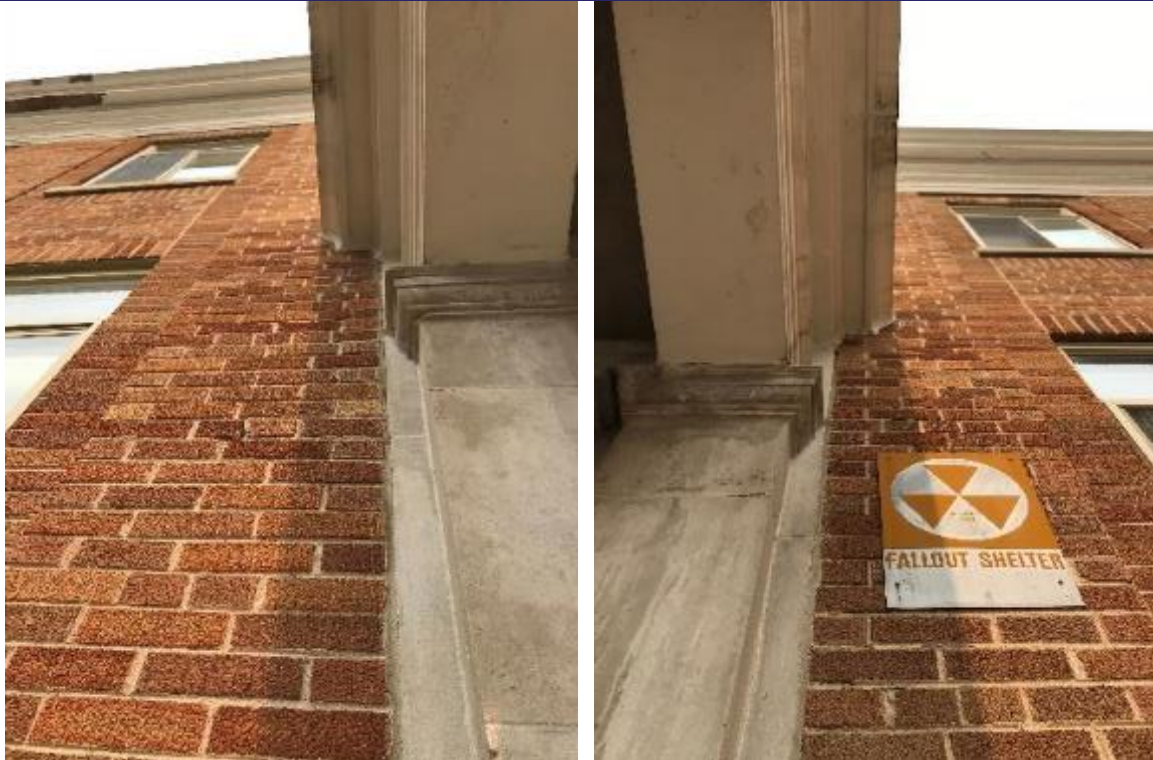
Tuck pointing, brick repair and possible kick out flashing at roof/wall intersection needed.

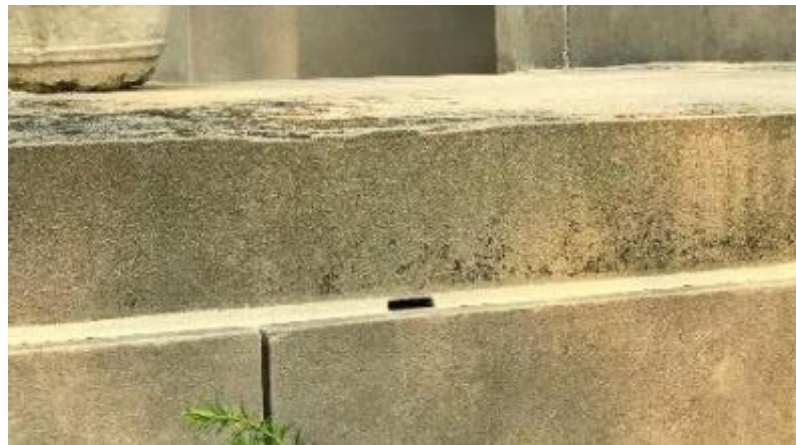
Sealant/caulk repairs needed at portico decorative stone joints.

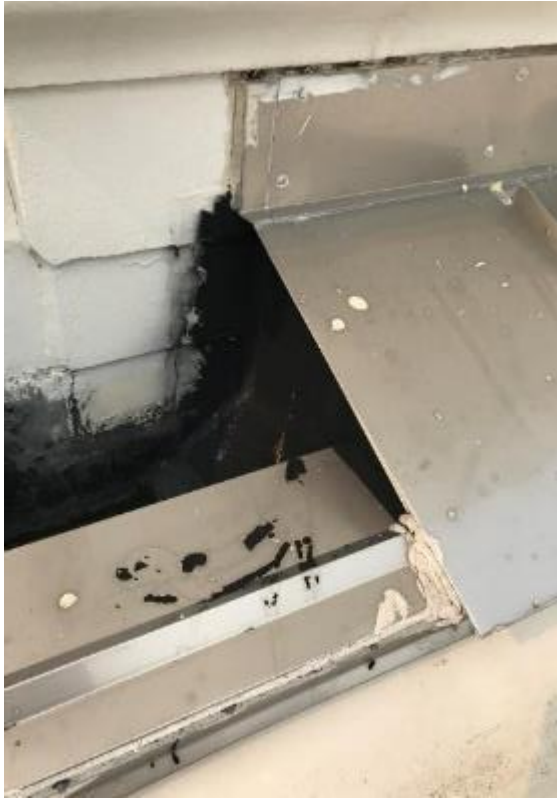
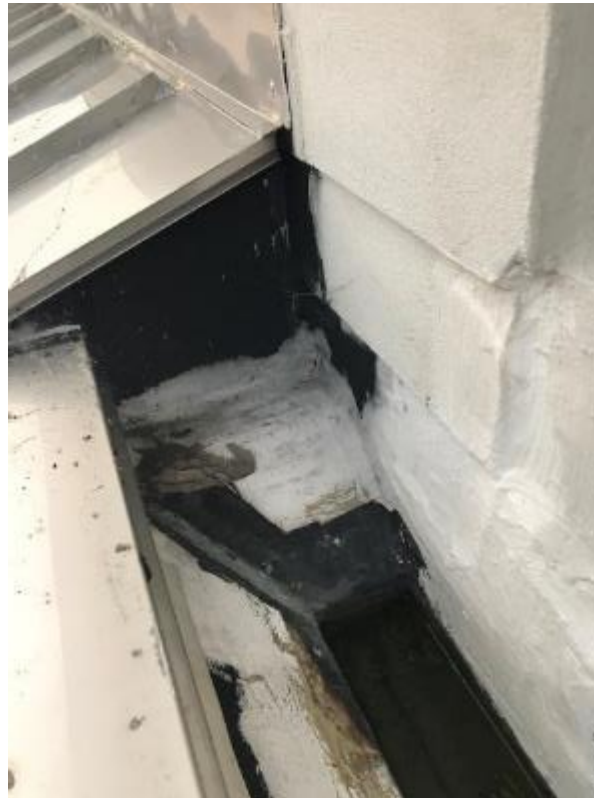
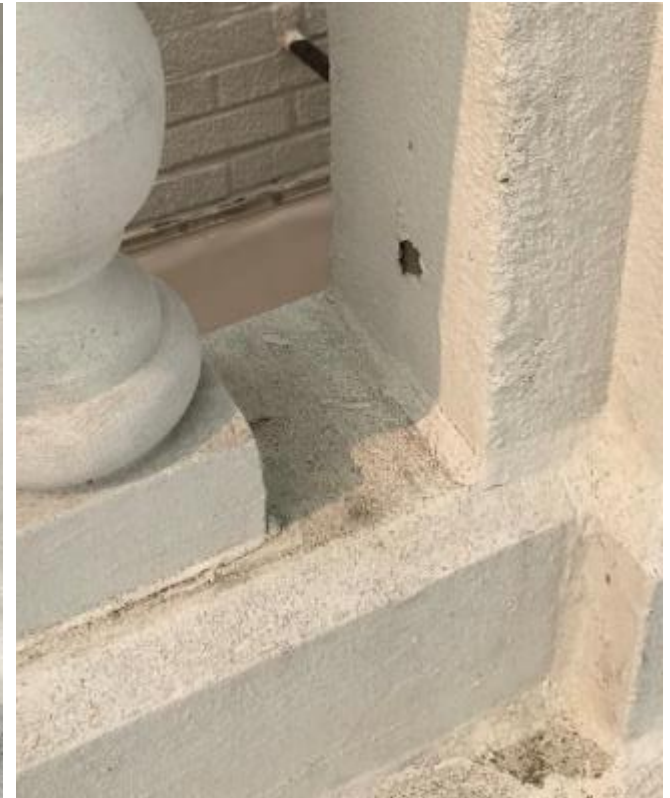
At the roof level, there are several places that need to have the waterproofing repaired which includes caulk, sealants, flashings, rubber membrane and paint. At the roof parapet, the caulk between the masonry/membrane and the decorative stone caps is completely missing in many places. Water is infiltrating in these gaps and can enter the masonry which causes additional problems. At the perimeter between the 1929 building and the 1977 building, the waterproofing should be repaired as well as there are a few locations inside the building at these locations where water infiltration has occurred.

1929/1977 building joint waterproofing repairs needed.

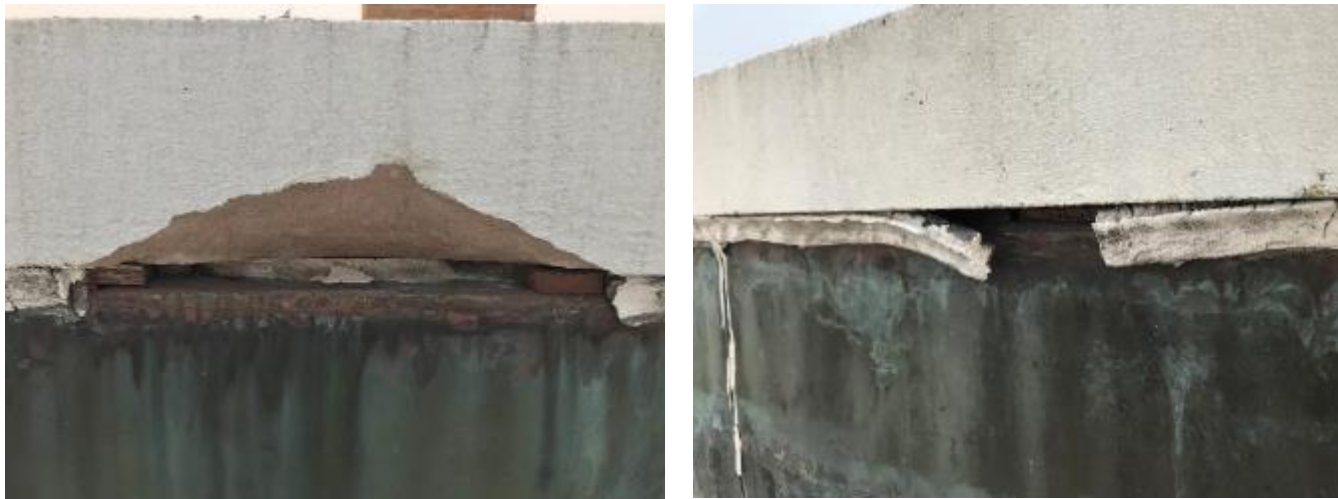
Roof parapet cap sealant and paint repair needed.

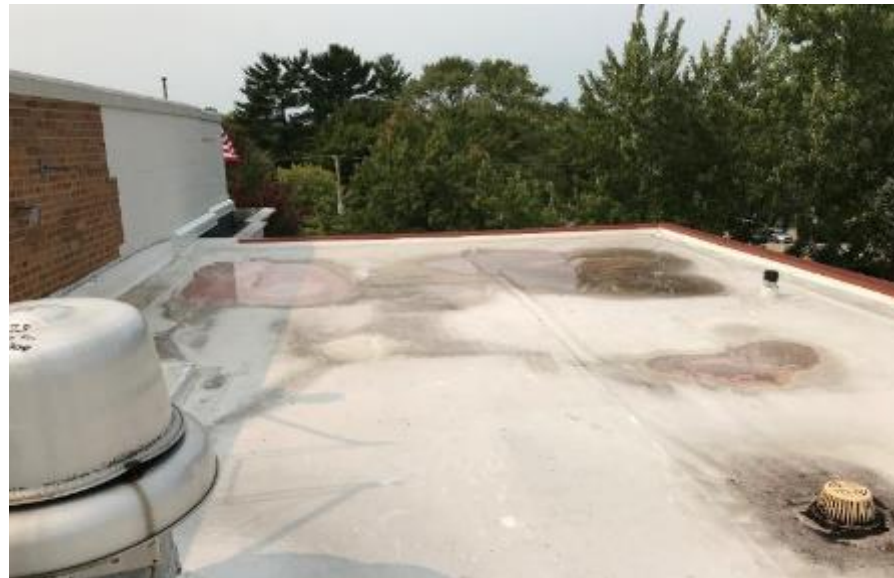
There are a few locations on the membrane roof where water ponding was evident which is likely due to the extremely low slope of the roof. It is difficult to have proper water drainage without ponding with slopes this low. The membrane roof itself appears to be in good condition currently. However, when re-roofing is needed in the future, additional tapered insulation should be installed to provide for better roof drainage.

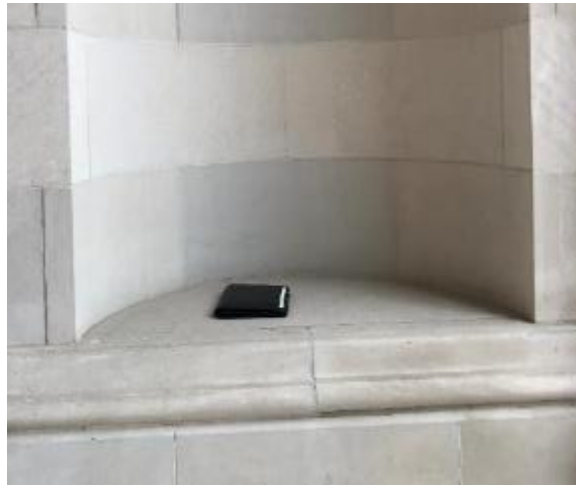
There are two semi-circular niches at the sides of the main entrance portico which originally had iron railings mounted into the stone and could be replaced. Though they are not shown on the original construction drawings, but there is evidence of their mounting and later infill. Niches like these typically housed statues, but there is not clear evidence that a statue was originally installed. The County could pursue the installation of these railings and meaningful statues at these niches, which should be coordinated with the historical review board.

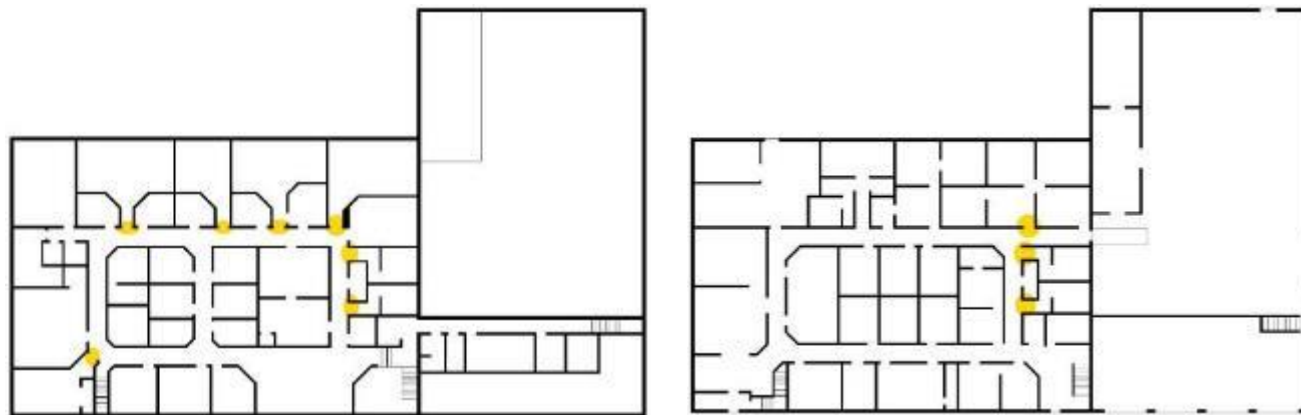
There are at least 10 doors which do not have the proper maneuvering clearances between the edge of the door and walls. The ADA typically requires between 12" to 18" clearance at the side of doors depending on whether it is the push/pull side, if the door has a closer or not, and how a person approaches the door. In some cases, up to 24" is required. Bringing these doors into ADA compliance would require installing automatic door openers and push buttons with back-up power in the event of building power loss which would be a costly upgrade. The other option to correct this would be to renovate, relocate walls and doors as necessary to have proper door maneuvering clearances. This option would be even more costly and cause a great deal of disruption while work is underway. See the plan below for locations of the non-compliant doors.

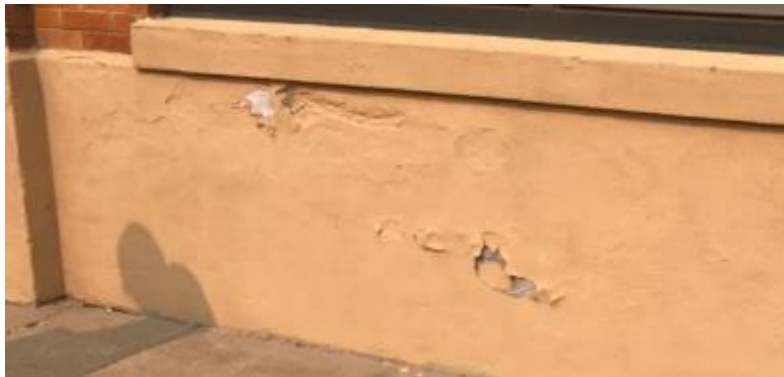
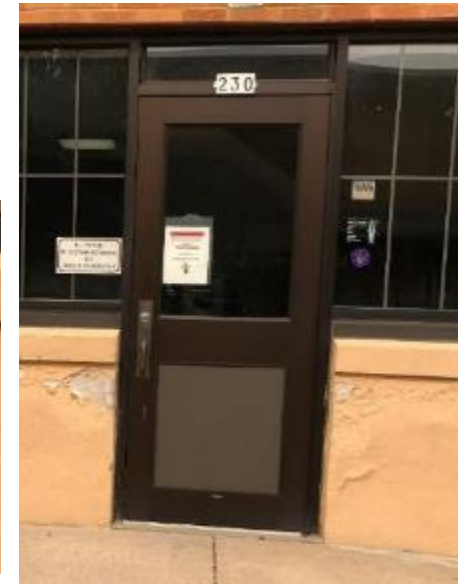
The concrete base has been painted a tan color which needs to be repaired. The paint not only improves the aesthetics of the bare concrete but gives the porous concrete an additional layer of waterproofing or water repellent depending on the paint used.

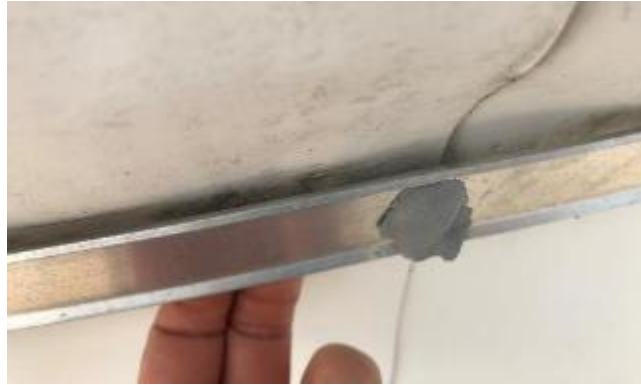
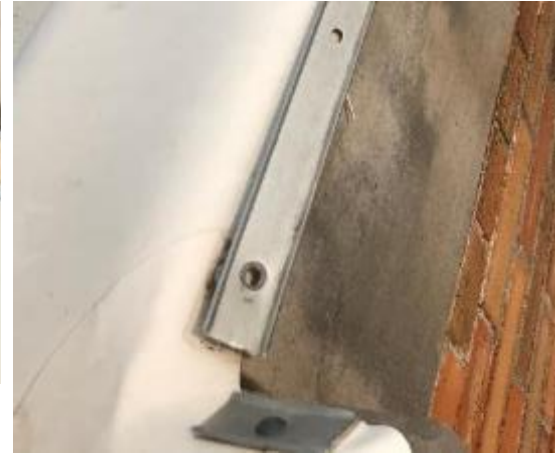
The membrane roof is believed to have been installed about 12-15 years ago and overall appears to be in good condition. There are several places where the caulk, sealant and termination bars should be replaced or repaired depending on the particular situation. Many caulks and sealants last for between 5 to 10 years depending on the formula and it is evident that repairs to these are necessary as they are failing now and should be part of a regular maintenance schedule.

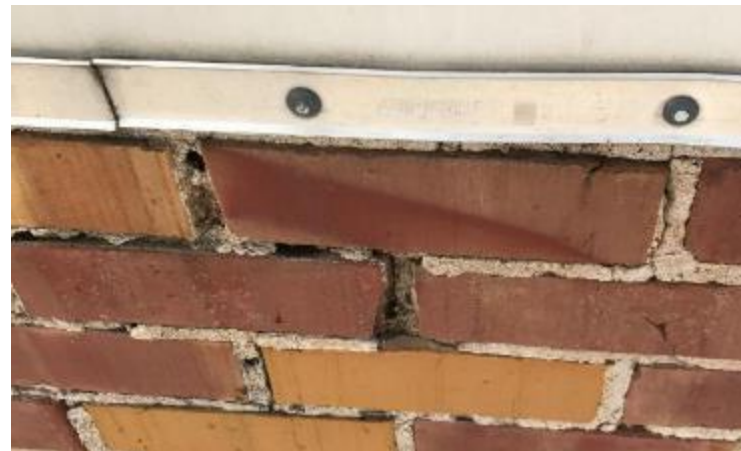
The brick and mortar are showing significant signs of erosion near the top of the parapet wall where there is little to no overhang or drip edges installed. These areas need to be tuck pointed, repair to any spalling bricks as needed to stop further damage and to make sure water does not continue to enter the wall assembly.

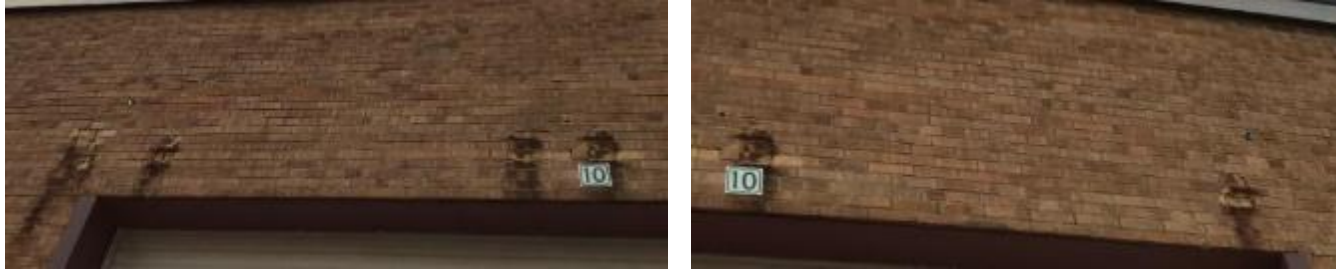
At the east wall near the large garage door, there is need for tuck pointing and brick repair. This appears to have been caused by previous signs or overhangs that were removed and then the masonry was not repaired. These should be repaired to limit further damage and make sure water does not continue to enter the wall assembly.

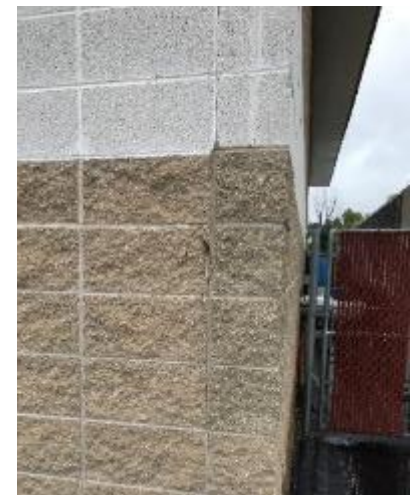
The only structural issued that was found during the walkthrough was the eastern wall of the sally port garage where there has been some separation between the two walls. There is some damage to a few concrete blocks at that location as well. This is likely caused by a small amount of differential movement or possibly the corner steel/grout reinforcement was not installed properly. Repair of the concrete block and tuck pointing would be the first step to prevent any water infiltration issues. If the condition worsens, steel angle/anchor reinforcing may be needed on the inside corner of the wall as well.

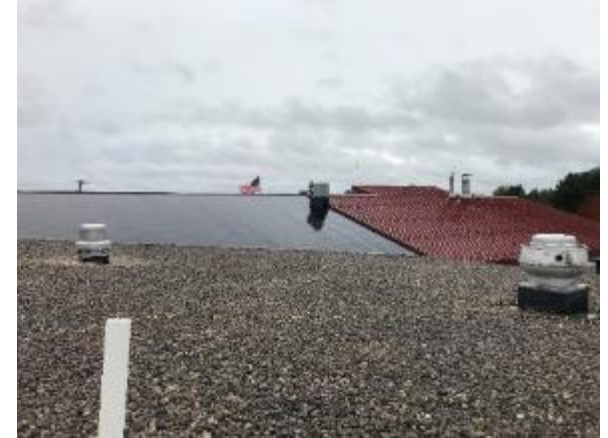
This facility has a mixture of metal roofing, black rubber roof and a ballasted roof. It is not immediately known as to the original reason to have three different types of roof finishes. In modern facilities, it is very rare to use a ballasted roof anymore due to the risk of high winds blowing the rocks around and creating projectiles that cause damage to people and property. The roof finishes are all believed to be original to the building which would put them just under 30 years old but do seem to be in good condition overall. Metal roofs typically last 40-70 years. Rubber roofs typically last 20-40 years depending on quality installed. Ballasted roofs typically last 40 years because the rocks give the rubber roof below a degree of protection.

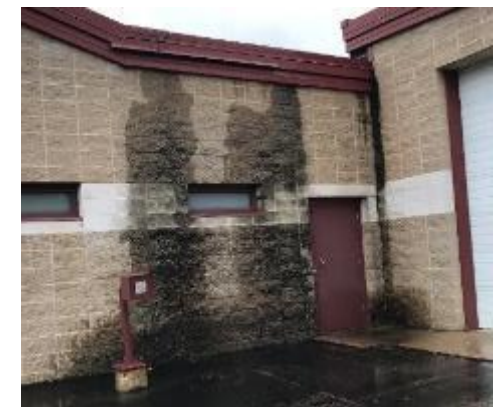
There were a few locations around the exterior where there is little to no roof overhang, and no gutter/downspout where you could see water running down the exterior face of the building. There does not appear to be much damage yet, but this is how it starts. Like the 1929 Courthouse where there is spalling and mortar erosion, the 1998 buildings concrete block and mortar will have the same issues over time if not addressed now. Water could start to enter at the joints between the doors/windows and masonry which would cause damage to interior finishes. The base of the concrete block wall to concrete foundation is also a critical location where water could start to enter the interior of the building and damage interior finishes. Overtime, water dripping on the ground will erode and damage concrete slabs, asphalt or grass which causes depressions and quickens the failure of those ground materials. The addition of gutters and downspouts is necessary to properly direct water away from these areas. It would be better yet if there were roof overhangs added but would require additional cost. On the bottom right image, notice the difference between the base of the wall on the left where there is an overhang but no gutter/downspout; compared to the right where there is an overhang, gutter, and downspout. The right side will hold up much better overtime than the area to the left where damage is inevitable.

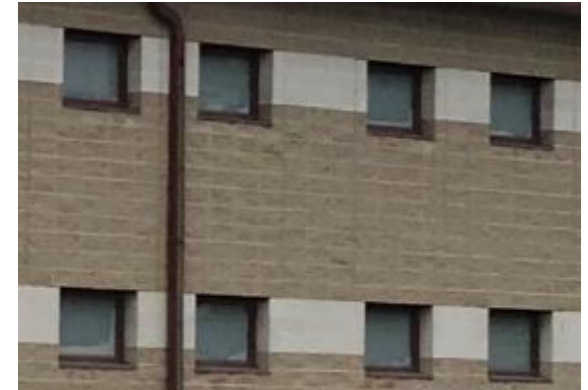
During our walkthrough, it appeared that the translucent film on the cellblock windows was delaminating from the glass at the intersection of glazing and sash. The fact that they are delaminating in the same locations leads us to believe this is due to condensation building up on the interior side of the glass at these detention grade windows. Condensation can damage the paint and eventually rust the steel window frames. To confirm if this is the reason, further observation throughout the year should be performed to monitor for condensation buildup which will likely occur when it is cold outside. Solutions to this range from adjusting the airflow against the windows at these locations, to replacement of the higher performing double-glazed detention grade window with a true translucent layer of glazing.

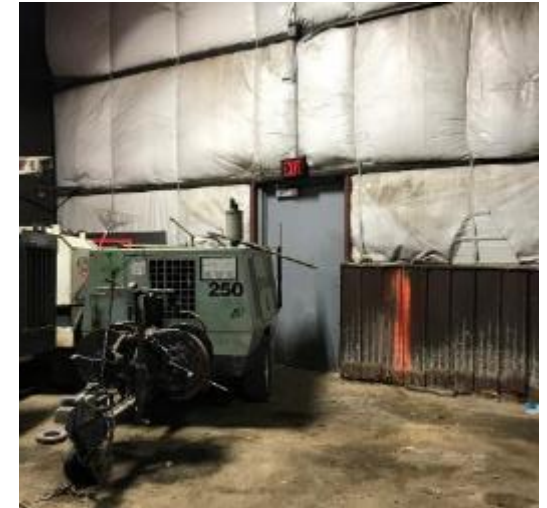
During the walkthrough, there was equipment parked in front of one of the main storage buildings exit doors. This piece of equipment should be moved to allow clear use of this exit door in the event of an emergency which would require a 48" x 60" clear space in front of the door, as well as a 44" clear path to the door.

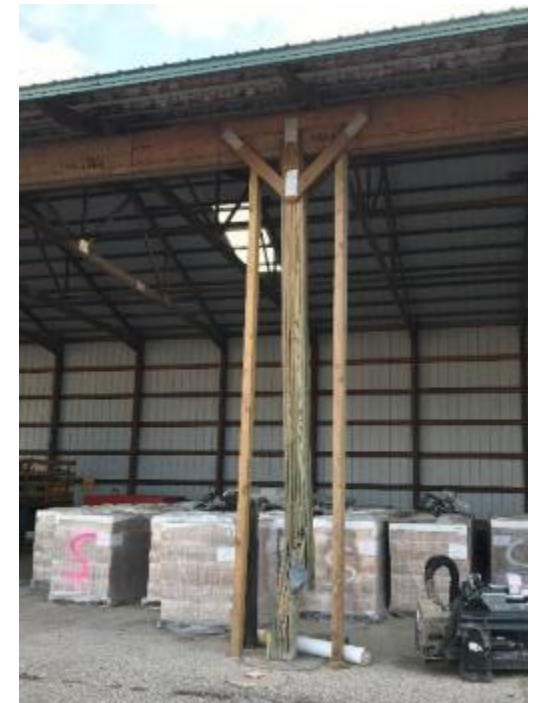
There are significant signs of moisture issues at the perimeter of the cold storage areas which are discussed in more detail in the building envelope portion of this report. These water and moisture issues can eventually cause damaging rust to the base connections for the steel structure which will shorten the lifespan of the structure that needs to be addressed.

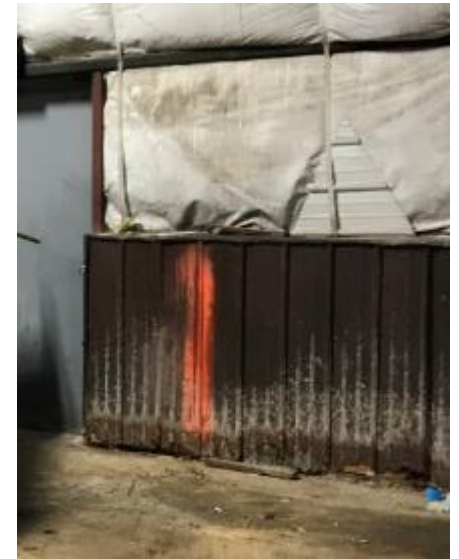
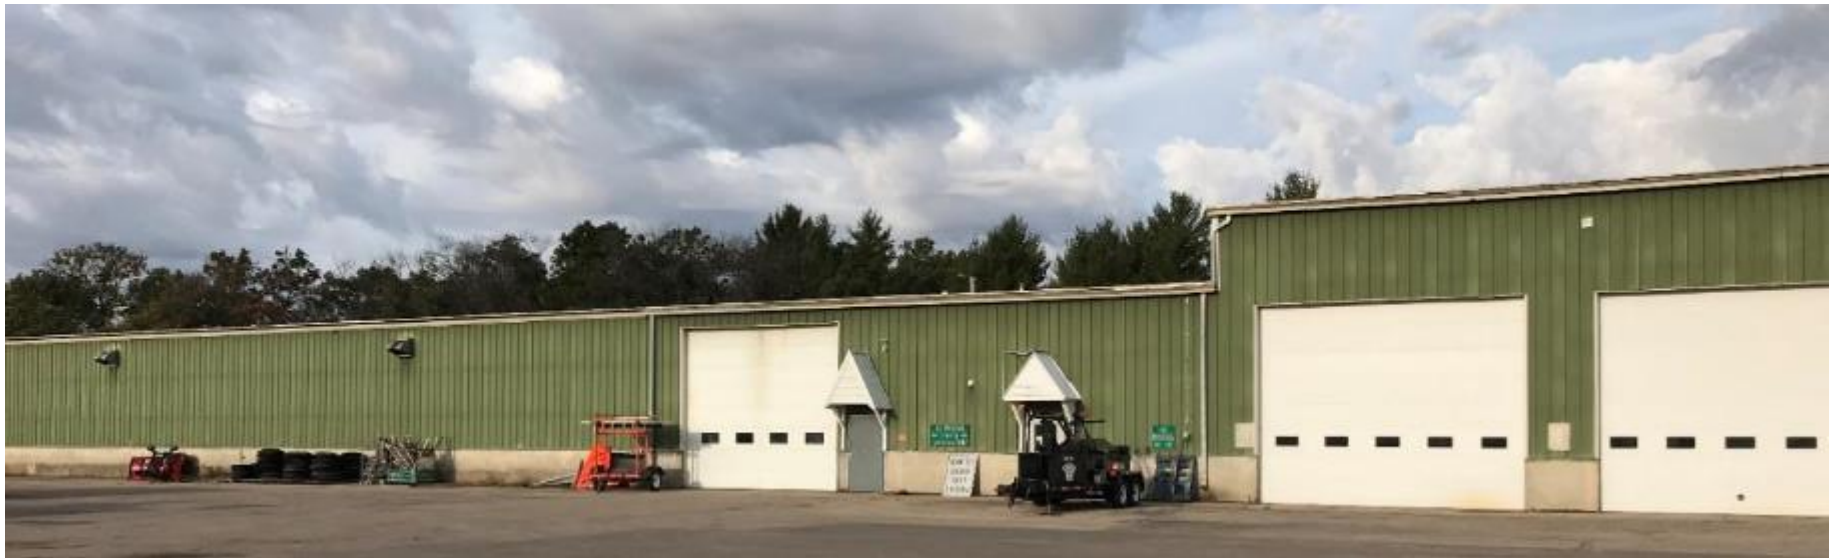
A commonly found issue at this facility which is common with other older, un-heated or semi-heated storage buildings is water and thermal issues at the base of the wall. There are signs of rust along the base of many of the interior walls where the metal panel is installed over the concrete wainscot. Concrete on its own is a porous material and will allow water to pass through. This condition is especially bad at areas where there are little to no overhangs, gutters, or downspouts to direct water away from the building. Concrete is also not a very good insulator and will allow cold through the wall which can then produce frost on the interior surface when met with warmer air. Staff has reported that frost is frequently seen on the interior metal panel and metal doors in the storage area. All these water and thermal issues are made worse by the fact that there is salt present in the storage garage because of the nature of the work the Highway Department conducts. On the bottom image, notice the difference between the base of the wall on the left where there is no overhang, gutter, or downspout; compared to the right side where there are gutters and downspouts. The right side will hold up much better overtime than the area to the left where additional damage is inevitable. Increasing the thermal insulation of the building, adding overhangs/gutters/downspouts, or removing the metal panel from the interior should be considered to improve the performance and limit additional damage.

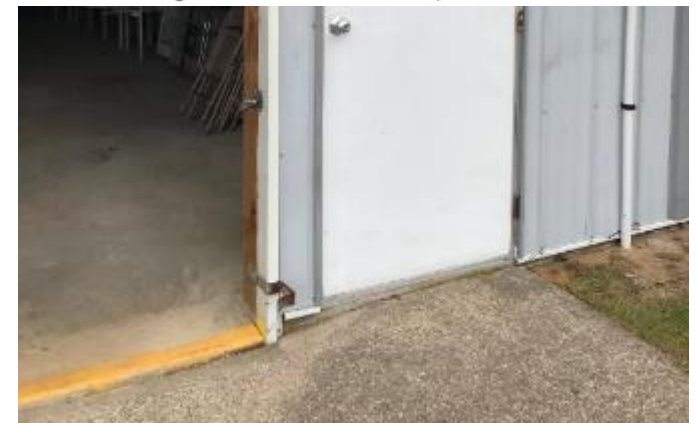
At most of the events barns and storage buildings, there were threshold issues at regular swing doors and large garage doors. See the diagram to the right which shows the maximum allowed thresholds or change in elevations for these locations. Thresholds, which have steeper verticals are difficult for persons in wheelchairs to wheel over and become potential trip hazards for anyone who is not fully aware of the height difference. Staff had tried to paint yellow warning lines at many of these locations. Also, at these locations, the concrete or asphalt paving that leads up to the doors has sunk. These pavements could be removed and replaced to create the proper threshold heights. At some locations, the integral metal thresholds for swing doors may need to be replaced as well if they do not comply with the ADA rules.

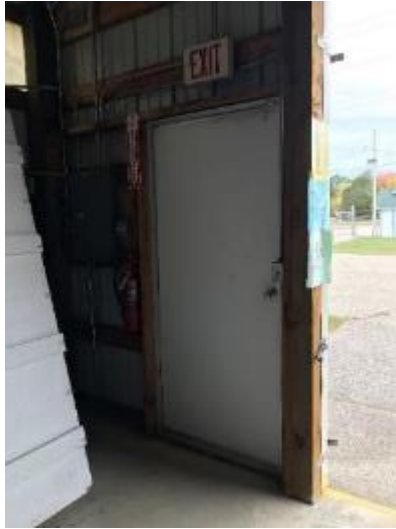
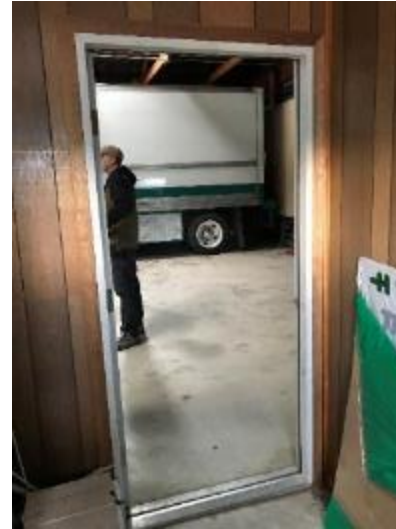
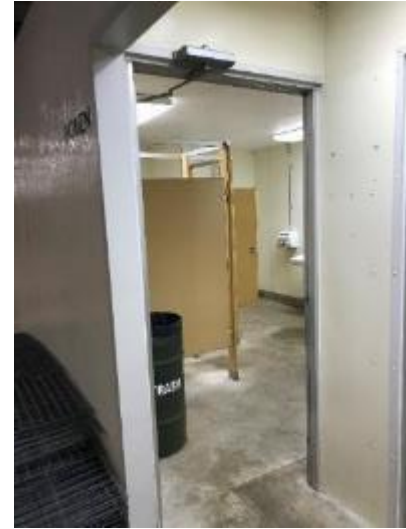
At several locations, door maneuvering clearances are an issue as well. Some due to the way the doors are mounted and not having the 12"-18" side clearance, some due to objects being stored too close to the doors. Solutions vary from simply moving the stored equipment, switching a door hinge side, to requiring adjacent walls be moved depending on the specific situation.

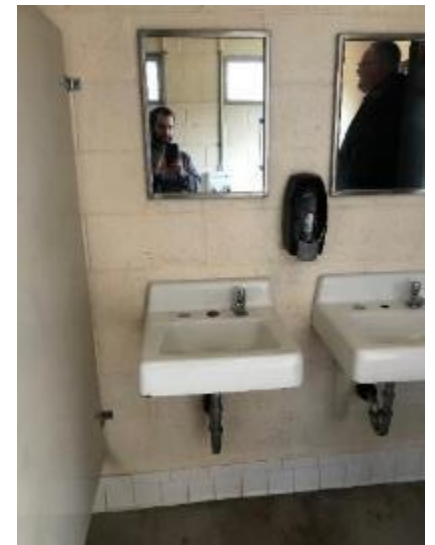
At the restroom building, there are a few issues that need to be addressed. The vanities are missing pipe covers and the mirrors are at the wrong mounting height. Pipe cover requirements are a simple installation. The ADA requires the bottom of the mirror to be no more than 40" above the floor. The mirrors on site were 50" above the floor.

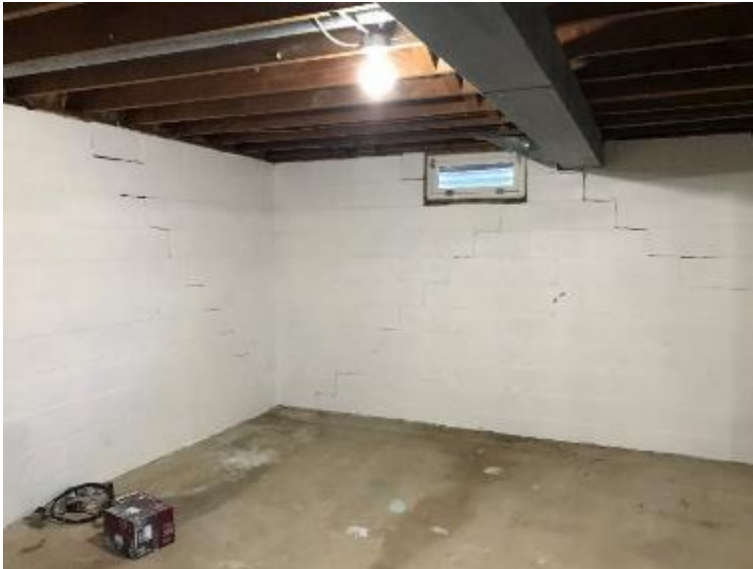
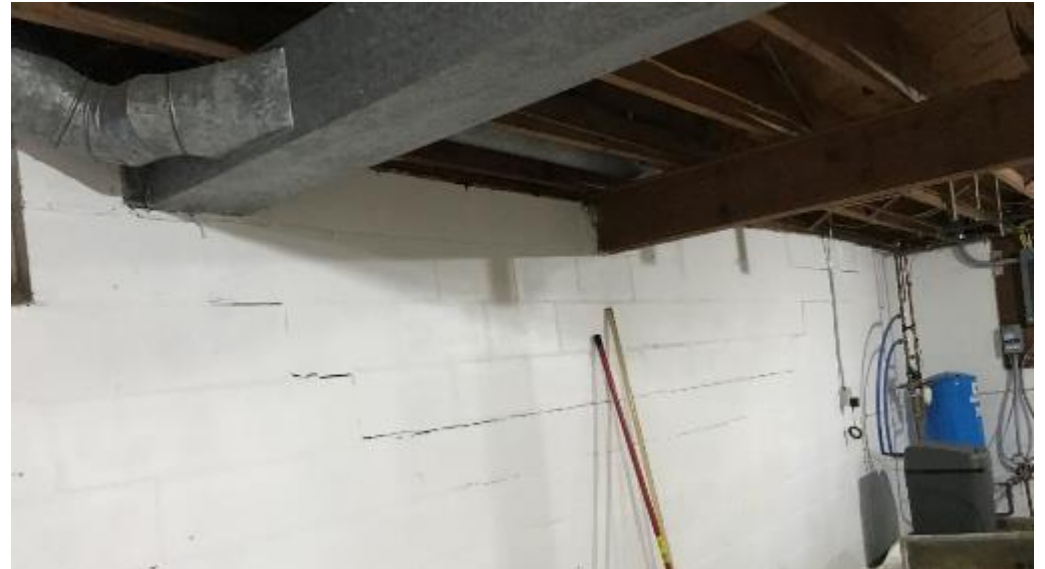
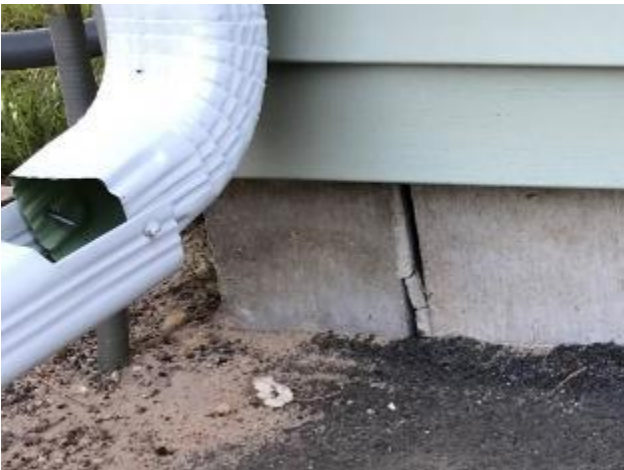
The cracks in the foundation are likely more of a building envelope and water infiltration issue than a structural one. There are cracks visible on both the interior and exterior of the concrete block foundation and should be tuck pointed and waterproofed. Exterior waterproofing is recommended as it is best to stop the water before it ever has a chance to penetrate the wall but does require a much greater effort. It is possible to remove ground surfaces around the perimeter of the building to expose about 2 feet of wall, install exterior waterproofing just at that area, then regrade to have proper water drainage.
