# WAUSHARA COUNTY MASTER PLAN

March 16, 2021

## INTRODUCTION

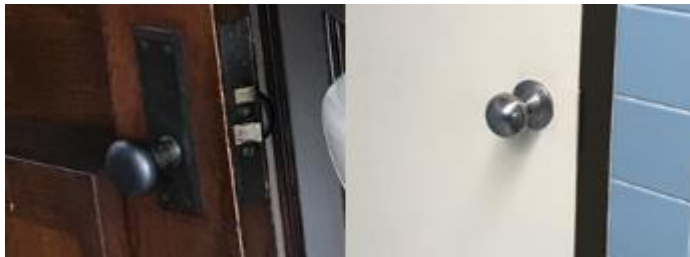
Examples of Accessible Door Hardware			
Handle	Pull	Bar	Lever

There are round twist door handles throughout the original 1929 courthouse, as well as some in the 1977 addition (typically at restrooms) which are not ADA compliant. The diagram below shows examples of ADA compliant door handles. Listed historic buildings are required to comply with ADA to the maximum extent feasible unless it destroys the historic significance of the building feature. An argument could be made that the round twist style handles in the 1929 portion of the Courthouse do in fact contribute to the overall historic nature of the building which warrants the County to further discuss this specific issue with State and National historic advisory boards.

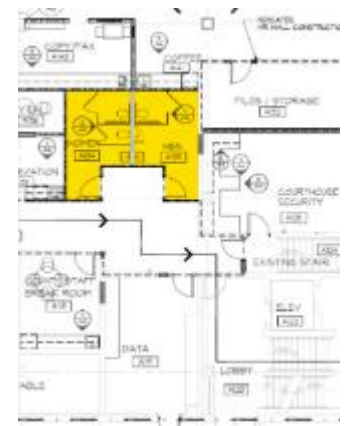
The first-floor restrooms toilet stalls shown to the right in the 1977 building do not meet the required ADA floor space clearances. The recommended solution for these restrooms would be to remove the partitions and convert the rooms into ADA compliant single user restrooms.

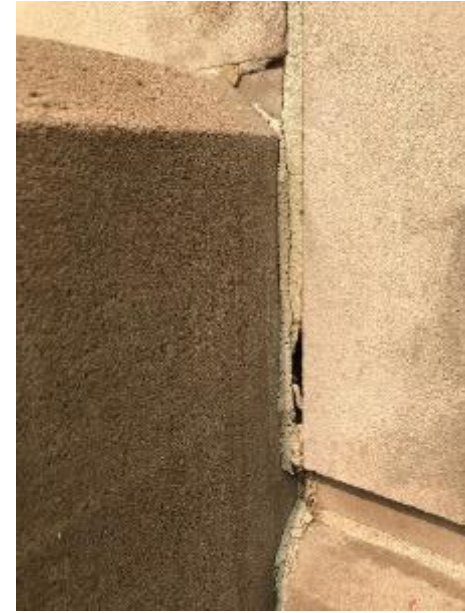
Tuck pointing needed.

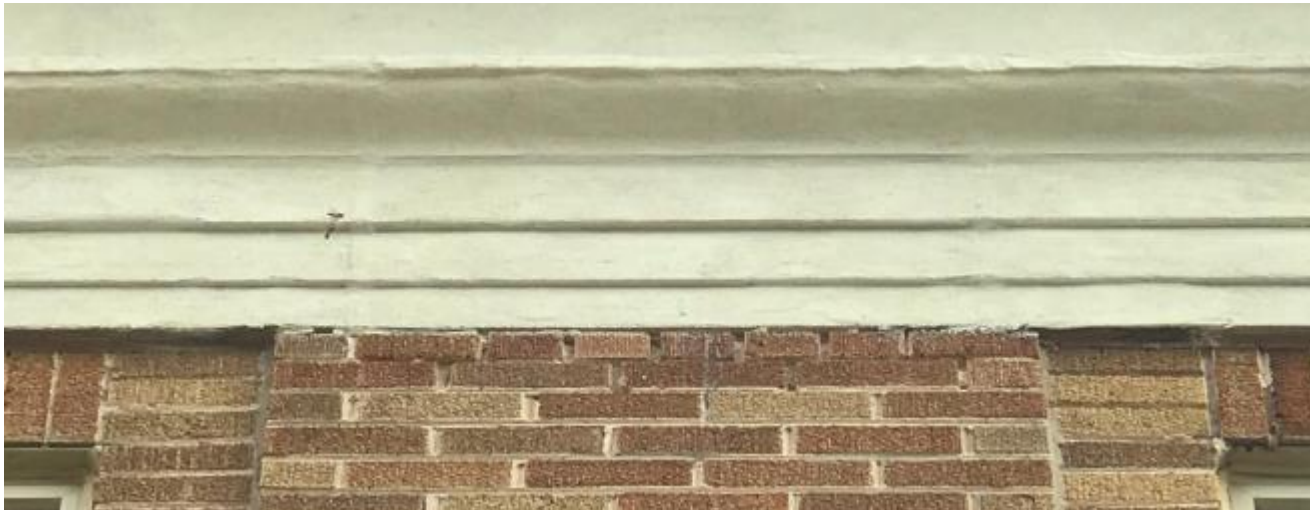
Intersection between brick and decorative stone architrave, mortar and brick has eroded from water.

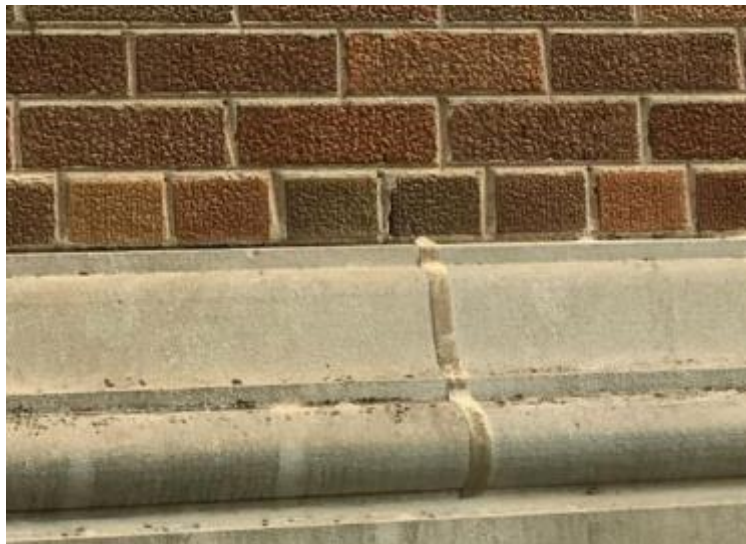
Intersection between brick and decorative stone base where mortar is eroding from water.

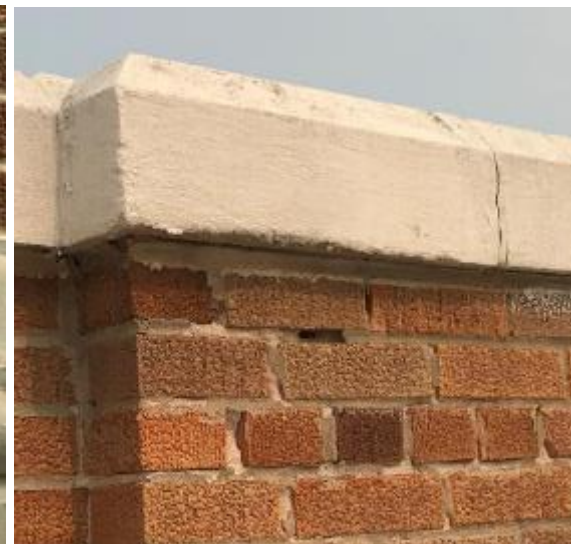
Tuck pointing needed at roof parapet.

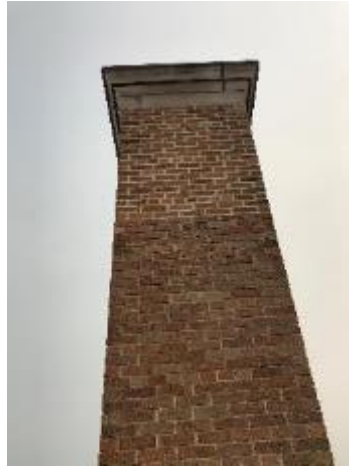
Tuck pointing, brick, decorative stone and paint repair needed.

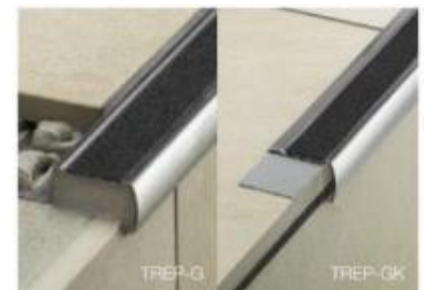
While we were performing a walkthrough, an occupant tripped on the tile steps near the main entrance of the 1977 building. It is believed that this was due to the person wearing a mask and their glasses fogged up, causing them to not adequately see the contrast between the stair nosing and ground floor. Maintenance staff quickly placed a high contrast warning tape on the steps and at other locations to limit this hazard. We recommend looking at a more permanent solution that would include a slip-resistant nosing with high contrast color abrasive strip like the photo (right).

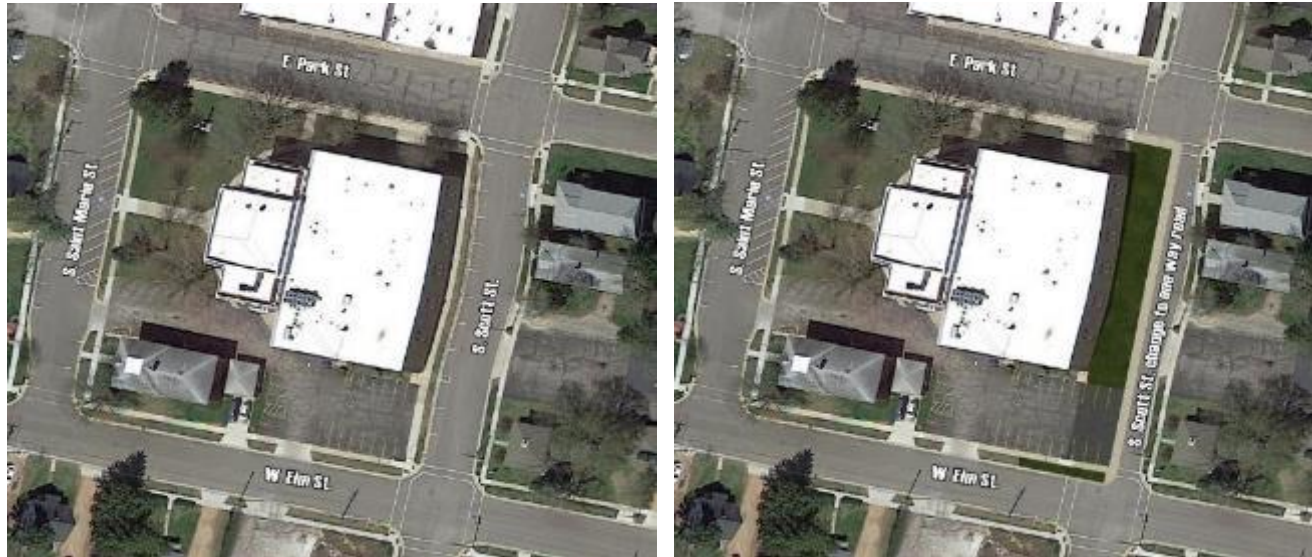
The western exterior wall of the 1977 addition lies directly on the property line with a public sidewalk and road adjacent. Current industry standards for courthouse design leaves open spaces otherwise known as the standoff zone, between the exterior wall of the courthouse and any road/public sidewalk as a security buffer. Correcting this would require closing and acquiring part of S. Scott Street between W. Elm Street and E. Park Street to create a one-way drive road at this section. Adding a standoff zone would allow for additional green space around the courthouse which also improves the aesthetics of the facility. Special consideration is required of the County to determine if any additional security measures regarding site layout are desired which also may include bollards or add planters. See the images below to compare the existing site and what it could look like with the standoff zone.

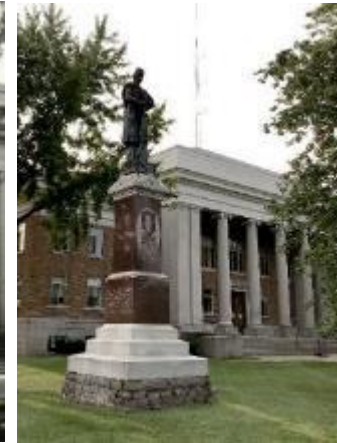
Existing 2020

The Yankee Soldier portion of the Civil War Monument should be corrected by rotating the soldier to face north as it is supposed to. This Civil War Monument has been around since at least the time of the previous courthouse which was destroyed by fire. Sometime after the 1929 construction of the courthouse, the base of the monument was modified, and the soldier may have been rotated at this time as well.

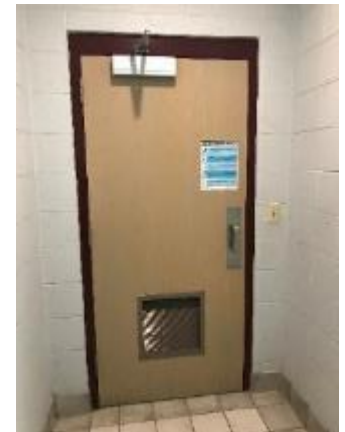
There are at least 10 doors which do not have the proper maneuvering clearances between the edge of the door and walls. The ADA typically requires between 12" to 18" clearance at the side of doors depending on whether it is the push/pull side, if the door has a closer or not, and how a person approaches the door. In some cases, up to 24" is required. Bringing these doors into ADA compliance would require installing automatic door openers and push buttons with back-up power in the event of building power loss which would be a costly upgrade. The other option to correct this would be to renovate, relocate walls and doors as necessary to have proper door maneuvering clearances. This option would be even more costly and cause a great deal of disruption while work is underway. See the plan below for locations of the non-compliant doors.

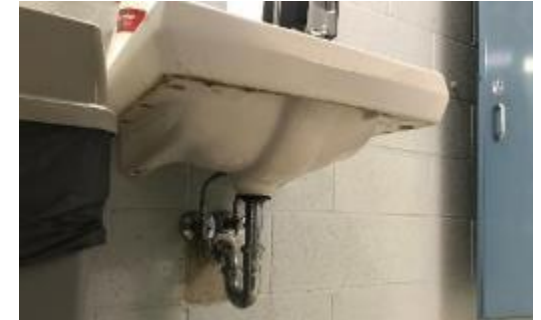
The multi-user restrooms do not have pipe covers installed. ADA section 606.2 requires exposed water supply and drainpipes under sinks to be covered to prevent a person from accidentally making contact with either a hot or cold pipe and potentially causing injury. This would be an easy fix by installing pipe covers.

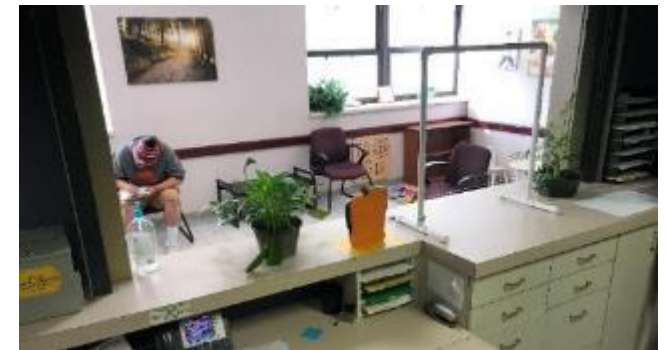
The Human Services Reception counter height is 42" above the floor which works for many people, but not those in a wheelchair. ADA requires that there is at minimum a 36" long section of counter that is between 28" to 36" above the floor for public transactions. To correct this, demolition and renovation of the existing counter would be required.

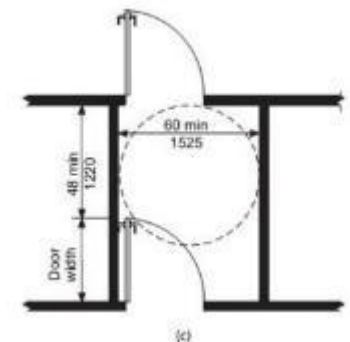
The entry vestibule doors do not provide the proper clearance required. They measure 42" between the doors versus the 48" that is required by code and ADA. The 48" distance between doors helps to ensure there is enough maneuvering clearance for a person to successfully navigate doors in sequence. In this instance, the automatic door openers that are installed do not negate the 48" requirement. Correcting this would require renovations by moving the interior wall and door further inside which would then make the reception lobby smaller which becomes another issue.

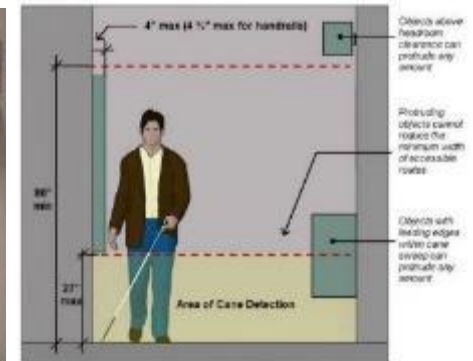
The timeclock mounted to the wall of the main corridor near the exam rooms is considered a protruding object. It sticks out further than the 4" allowed dimension and does not have any part of the object within the cane detection zone. This could be corrected by constructing a small built out element that would be detectable within the cane detection zone, which would reduce the usable width of the corridor. Another solution would be to relocate the device to another area that is not in a major corridor and complies with ADA requirements.

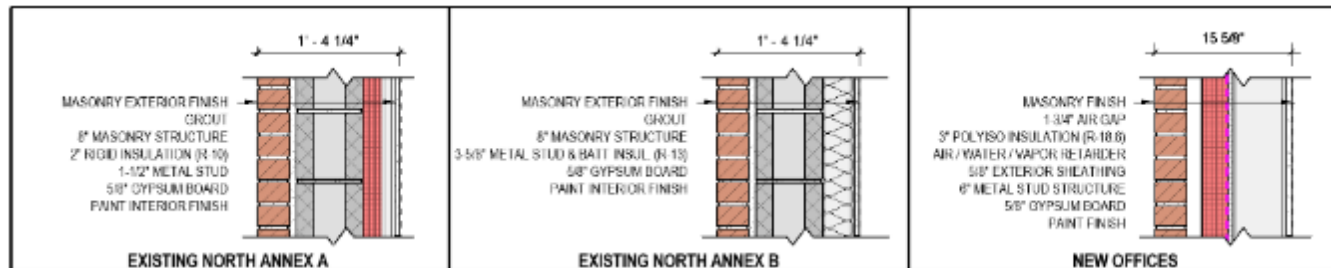
Since no construction drawings were available from the original construction or the renovation, we are forced to make an educated guess as to the make-up of the wall assembly. The exterior walls are bearing masonry walls with brick, grout, and concrete block. It was not common to include rigid insulation in masonry walls until the 1970's. During the renovation between 20 and 30 years ago, there appears to be metal studs that line the interior side of the masonry. Without putting holes into the walls, we cannot be certain if any insulation exists or the exact make-up of the wall assembly. The diagrams below show examples of how some masonry buildings have been renovated to include insulation as well as compare to a typical new building assembly. It is important to note that the assembly insulation values are based on "effective thermal resistance". This means that if you analyze the wall assembly at the center of insulation, you might have material rated at R-13. However, if you consider that at every 16" on center and at the top and bottom of the framing there are metal studs which are a highly effective heat conductor, you reduce your overall insulation ability by roughly 66% for actual performance. This "effective thermal resistance" analysis shows why it is so important to have continuous insulation.

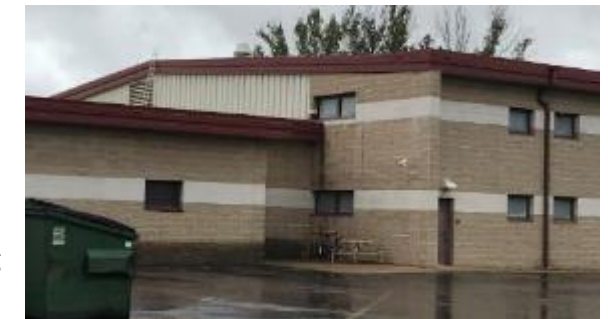
There were a few locations around the exterior where there is little to no roof overhang, and no gutter/downspout where you could see water running down the exterior face of the building. There does not appear to be much damage yet, but this is how it starts. Like the 1929 Courthouse where there is spalling and mortar erosion, the 1998 buildings concrete block and mortar will have the same issues over time if not addressed now. Water could start to enter at the joints between the doors/windows and masonry which would cause damage to interior finishes. The base of the concrete block wall to concrete foundation is also a critical location where water could start to enter the interior of the building and damage interior finishes. Overtime, water dripping on the ground will erode and damage concrete slabs, asphalt or grass which causes depressions and quickens the failure of those ground materials. The addition of gutters and downspouts is necessary to properly direct water away from these areas. It would be better yet if there were roof overhangs added but would require additional cost. On the bottom right image, notice the difference between the base of the wall on the left where there is an overhang but no gutter/downspout; compared to the right where there is an overhang, gutter, and downspout. The right side will hold up much better overtime than the area to the left where damage is inevitable.

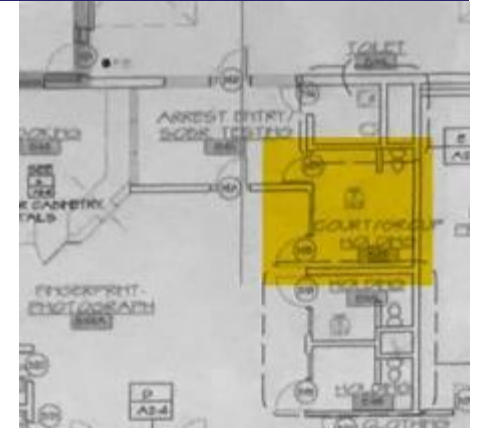
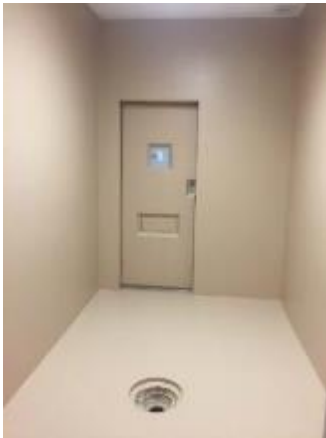
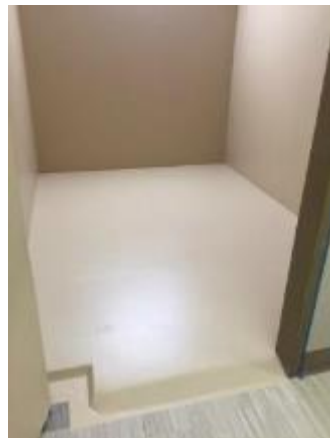
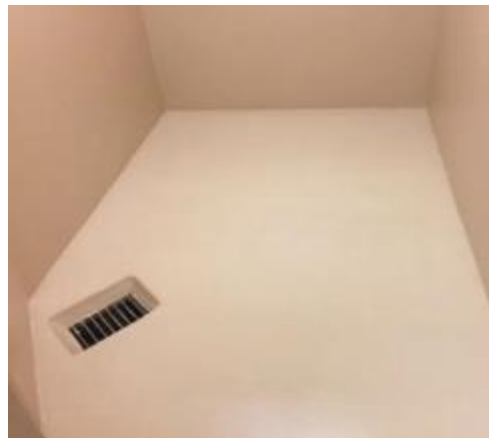
Currently, the Jail does not have a padded safety cell but does have a layout that could easily incorporate one. The room shown to the right that is called Court/Group Holding is ideal to be converted to a padded safety cell because of the dual doors from the main Booking area and the Arrest Entry. When individuals are under the influence of substances or other issues, which make them particularly dangerous to themselves or others, having a padded safety cell easily accessible is one of the best existing methods to diffuse the situation. The padding is installed on all walls, floors, ceilings, backs of doors or other hard objects. The rooms typically do not have a regular toilet, rather a flushable drain as an additional method to reduce injuries. See the images below for an example of a padded safety cell.

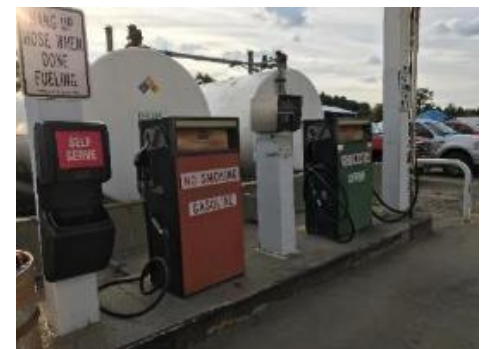
The fuel pump monitoring system needs replacement as it is no longer supported and makes for an inefficient way to track fuel usage. See the space and program assessment for additional information on this and other site related topics.

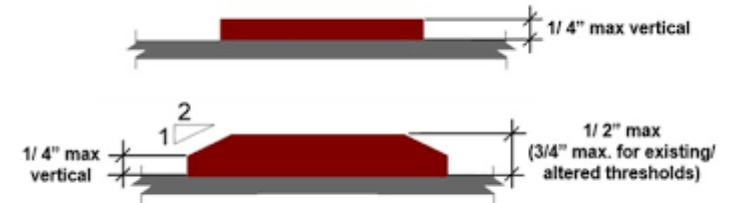
At most of the events barns and storage buildings, there were threshold issues at regular swing doors and large garage doors. See the diagram to the right which shows the maximum allowed thresholds or change in elevations for these locations. Thresholds, which have steeper verticals are difficult for persons in wheelchairs to wheel over and become potential trip hazards for anyone who is not fully aware of the height difference. Staff had tried to paint yellow warning lines at many of these locations. Also, at these locations, the concrete or asphalt paving that leads up to the doors has sunk. These pavements could be removed and replaced to create the proper threshold heights. At some locations, the integral metal thresholds for swing doors may need to be replaced as well if they do not comply with the ADA rules.

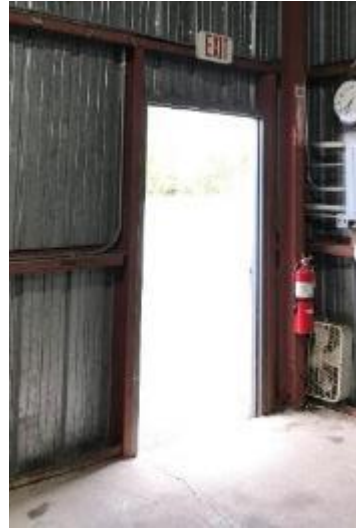
At several locations, door maneuvering clearances are an issue as well. Some due to the way the doors are mounted and not having the 12"-18" side clearance, some due to objects being stored too close to the doors. Solutions vary from simply moving the stored equipment, switching a door hinge side, to requiring adjacent walls be moved depending on the specific situation.

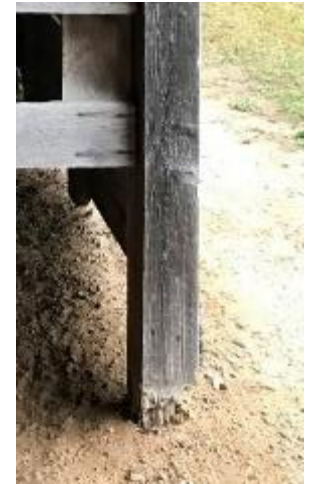
At the Racehorse Barn, many of the structural wood columns are showing signs of rot at the base where they are in contact with the dirt floor. Without protection, wood columns can easily rot at the intersection of the ground because of the wet and dry cycles they experience frequently. There are many products and methods used in modern wood post frame construction which keep the base of the wood columns above ground to increase lifespan. It is possible to make a corrective fix for the existing posts which includes products like Perma-Column concrete footings and helical piers. In addition to column rot, the rafters are sagging due to the large overhangs and there are stress cracks at several interior beams and other structural members. Due to the cost associated with the structural repairs, this may be justification for replacement of the Racehorse Barn if the County decides it is their preferred path.

Existing columns.

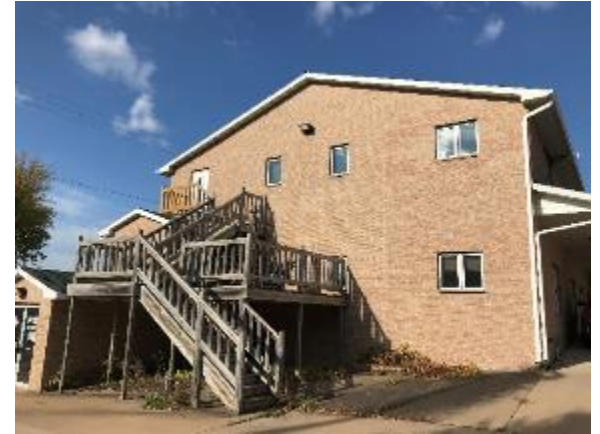
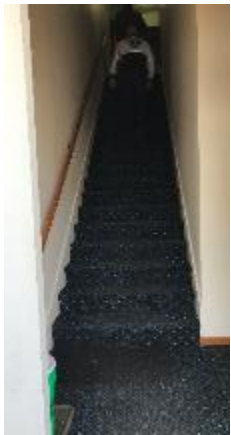
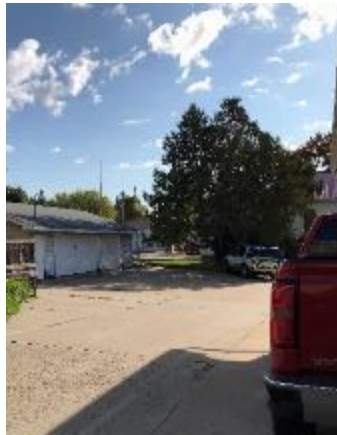
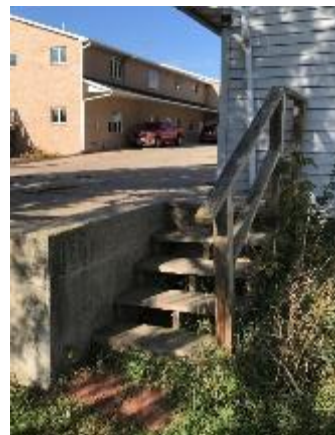
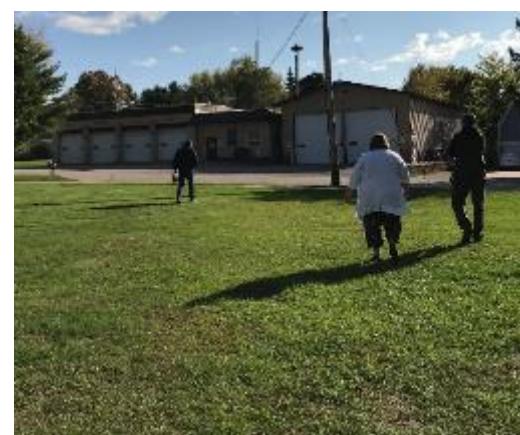
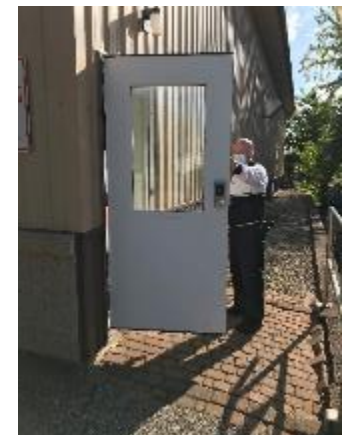
### Building Site:

The County should strongly consider using a single building that can house the staff quarters and ambulance garage. There may be existing buildings within Poy Sippi that could be converted to meet the needs of EMS. The County could also consider purchasing property in the surrounding area and renovate or construct a new satellite facility like they have done in Hancock or Wild Rose effectively.

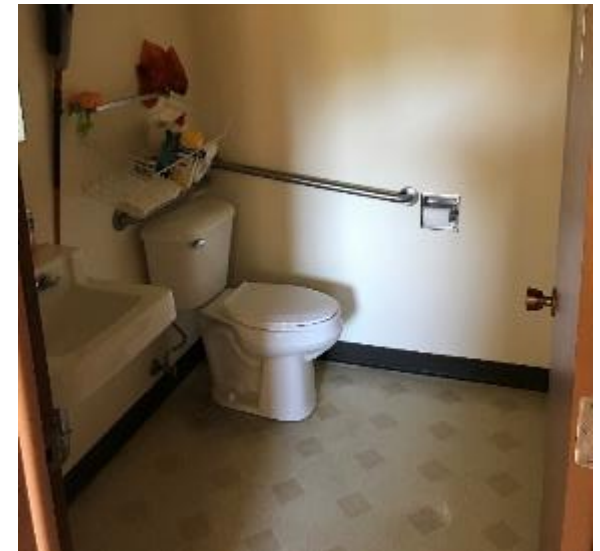
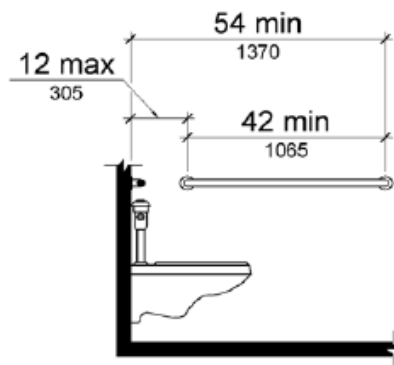
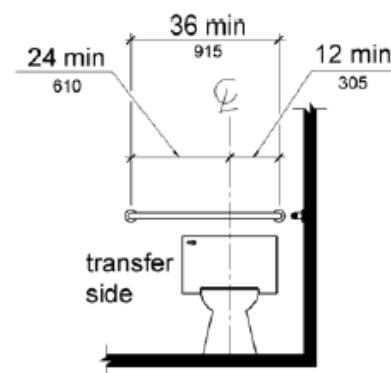
The lower-level restroom that serves the Senior Dining Center is not fully accessible. The sink needs pipe covers to prevent accidental contact with hot/cold pipes. The grab bars that are currently installed also need to be corrected. There is a toiletries shelf that is hanging which prevents the back grab bar from being properly used. Also, the back grab bar is supposed to be 36" long, and the side grab bar should be 42" long to meet ADA standards. The side grab bar was installed at a slant because it would have interfered with the already installed back grab bar, as well as the semi-recessed toilet paper dispenser. The overall dimensions of the room are also smaller than what is required for the layout to be considered fully accessible, so an expansion of the restroom is recommended. These items should be corrected if the Senior Dining Center is to remain at this location.

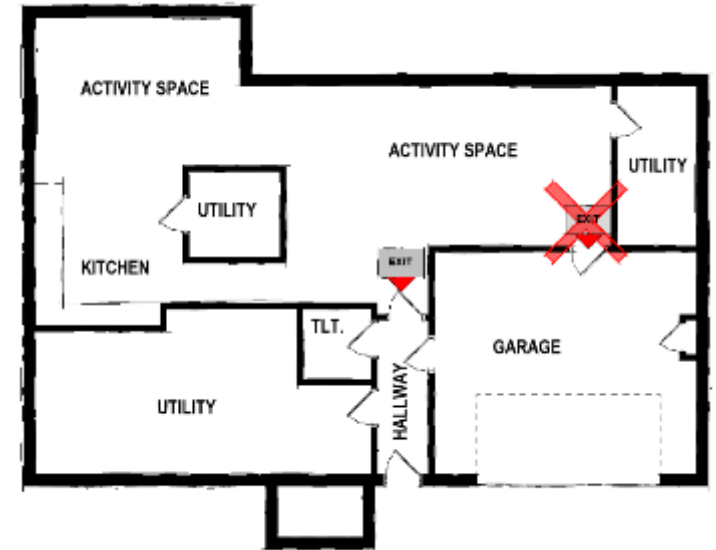
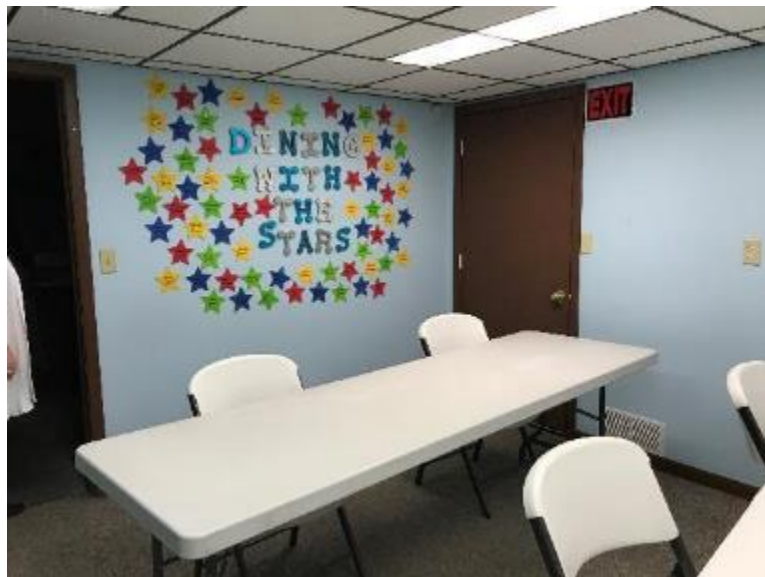
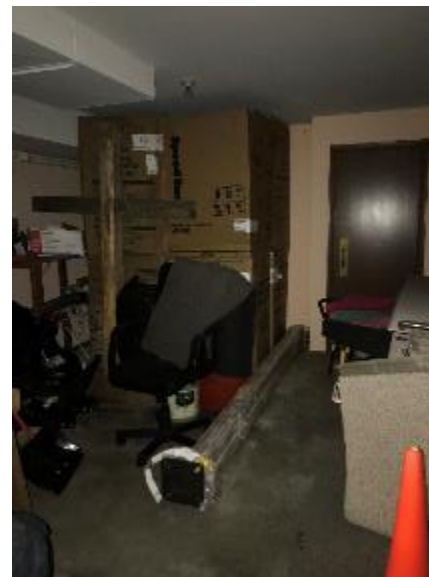
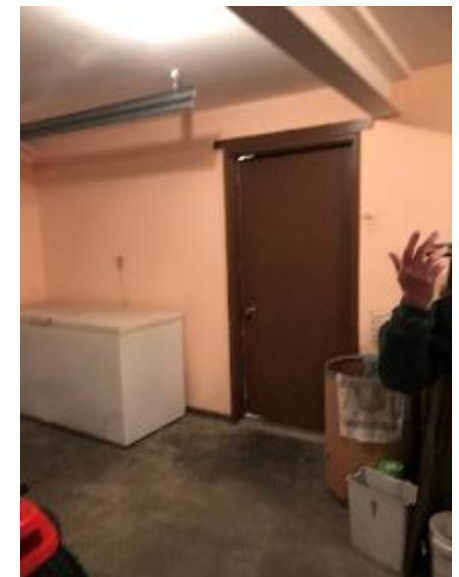
The exiting plan for this building should be corrected. During the walkthrough, we discovered two exit signs in the lower level. One exit sign leads out the hallway to the outside and the other exit sign is a door which leads into the garage. The exit sign that leads into the garage was not an illuminated sign as required, the garage had no egress lights and was being used as storage with no obvious direction where to go from there. There was a door to an electrical panel and then a door that leads from the garage to the hallway which is part of the main egress path but there was no illuminated exit sign guiding you to that door. If there was a fire and great deal of smoke to hinder visibility, it would be very difficult for people to figure out the route under duress. If this space is posted to 49 or fewer occupants, only one exit path is required. The door that separates the hallway from the activity space would also benefit from a glass lite which would not only offer additional natural light but would further emphasize the exit path beyond. See the plan diagram to the right as well as photos below of the space.

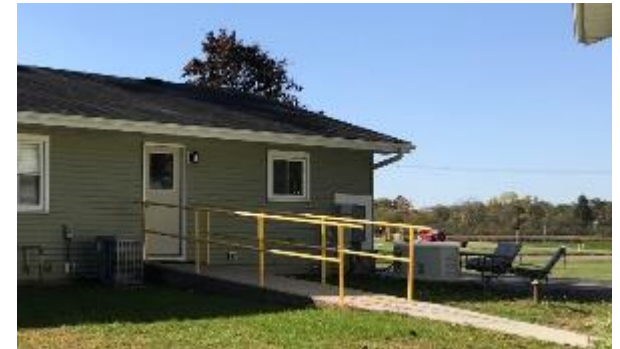
The threshold of the rear door is typical residential that has greater than ¼" vertical height difference between the concrete ramp and the threshold, so it cannot be considered accessible. The guardrail that is installed does not meet full requirements as there is no edge protection at the base. This could be resolved by welding a steel plate near the base of the railing.

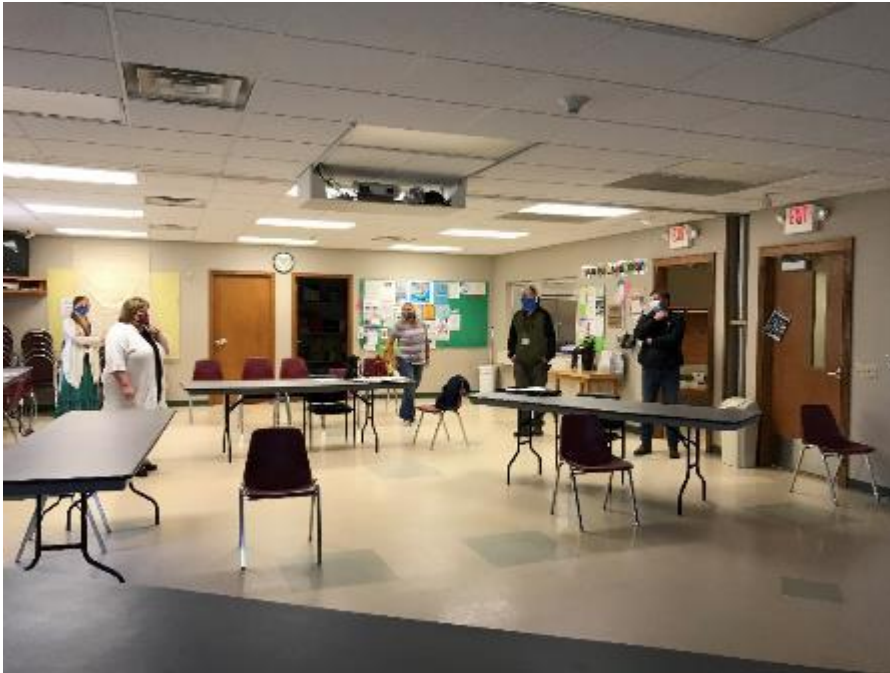
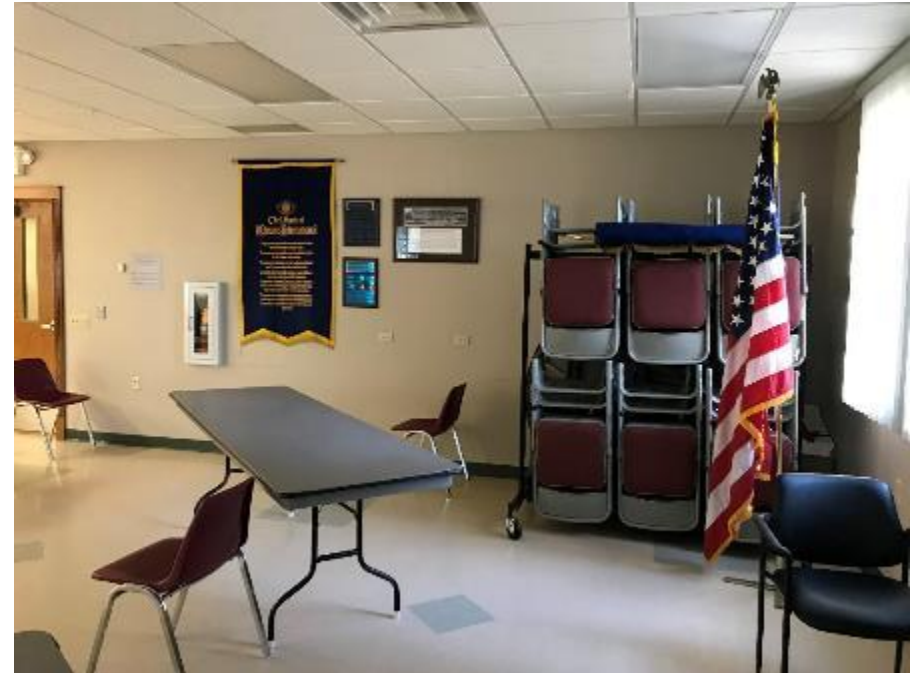
The activity spaces host a large variety of events and there is not enough storage space to move all the existing tables/chairs out of the main spaces. An addition adjacent to the mechanical room could accommodate this additional storage.
